MARYLAND GEOLOGICAL SURVEY Merryman Hall The Johns Hopkins University Baltimore, Maryland 21218 (301) 235-0771

COUNTIES (MD/PA)	WASHINGTON/FRANKLIN
M&D milestone no	93 (96)
MHT-HSI no.	WA-IV-093
	•

FIELD SHEET: MASON & DIXON LINE, MARYLAND-PENNSYLVANIA BOUNDARY MARKER SURVEY

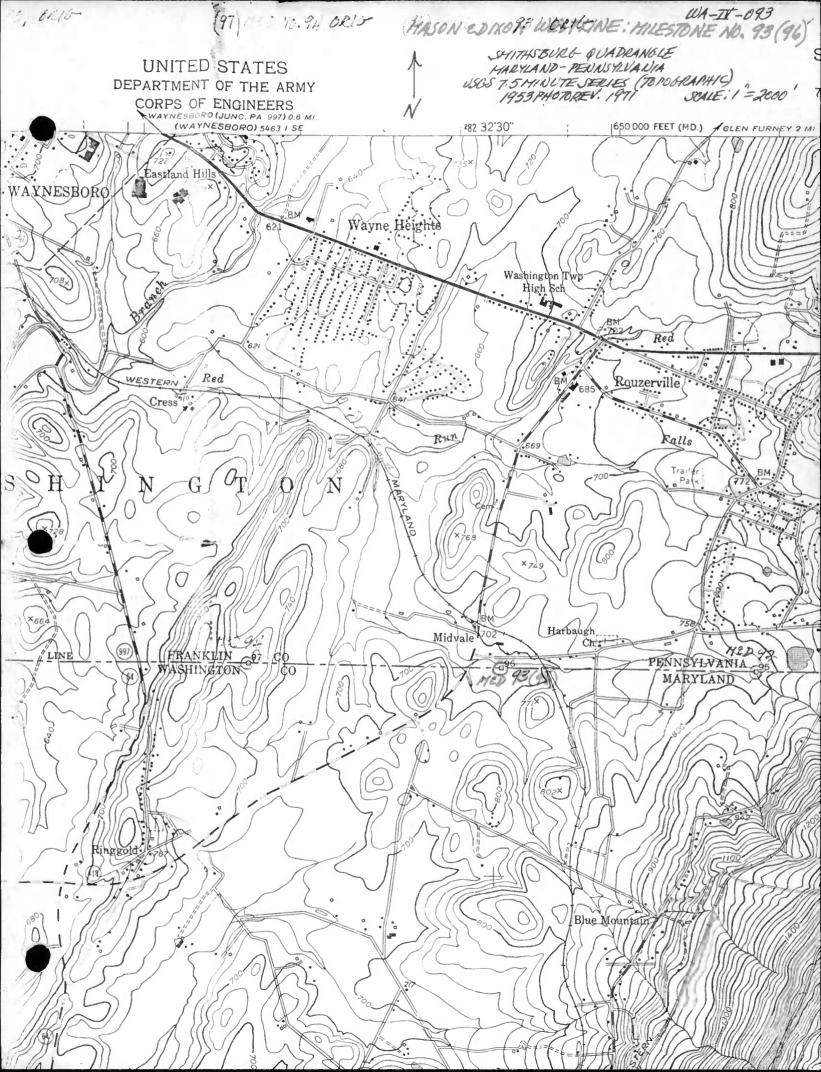
DESCRIPTION/MEASUREMENTS: original/replican/replacement/date 1767; oolitic limestone post, about 1' square, standing about 1' above ground; P on N/S, M on S/S
N face (PA): 12% wide x 16" high; P & circle panel distinct; some fluting & margins remain; chips top corners & edges

1979-81 Inspection notes: order no. 93 (96); photos/negatives/slides no. 93 (96) 93 (96). Original M&D milestone of 1767 in place, in good condition, firmly set. Letters and most embellishments distinct and intact. Large chips top edges and corners. Protected by owners, but vulnerable to damage by farm machinery.

As with many other MD-PA boundary monuments in the middle of cultivated fields: MGS will want to make arrangements for marking this monument so as to prevent further chipping by farm machinery. Most such damage is inadvertent, especially in corn fields where the monument is completely hidden during the growing season. Horace Waybright of Frederick County (M&D 78) solved this problem by a tail pipe with flag--tall enough to be seen above any crops.
